Case Study

Bluff Profile Analysis along Lake Michigan

Dr. David Mickelson Geo-Professional Consultants

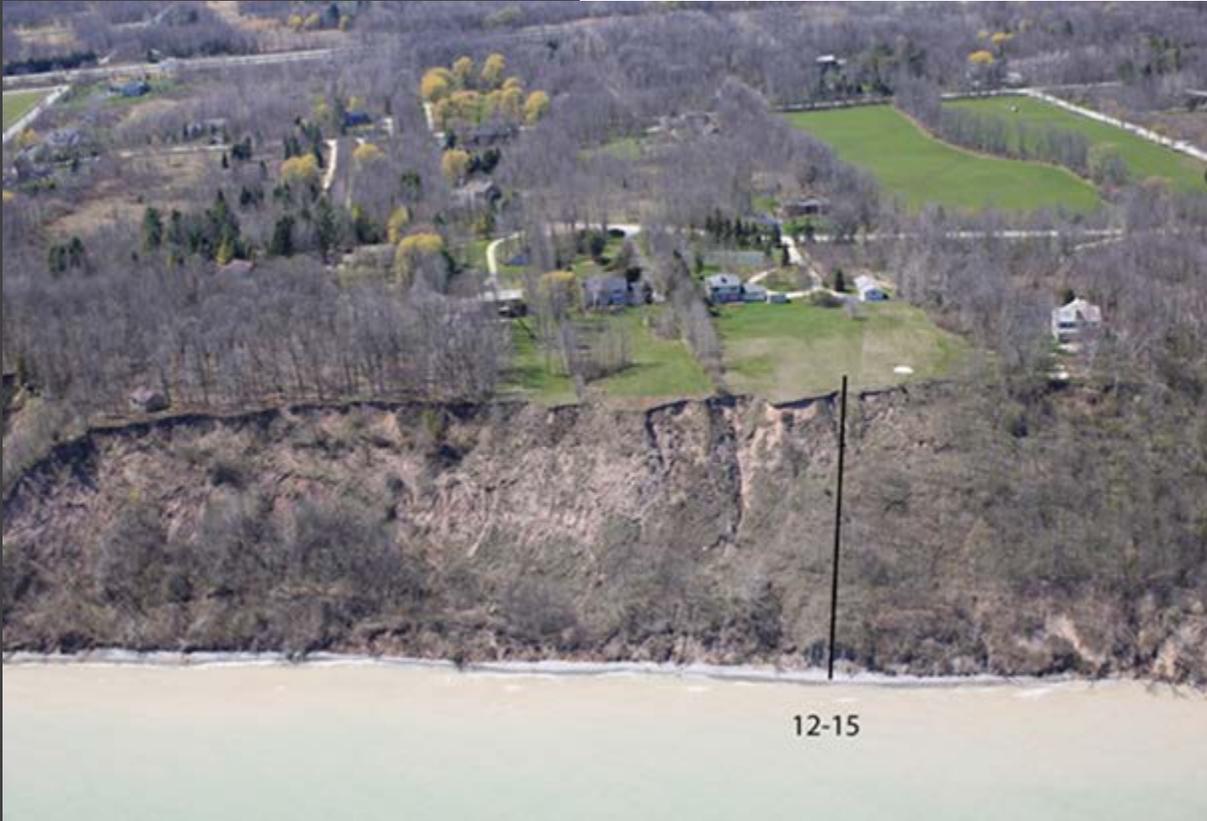
Figure 1 (Above)- Oblique aerial photo of profile 12-15 on Lake Michigan shoreline

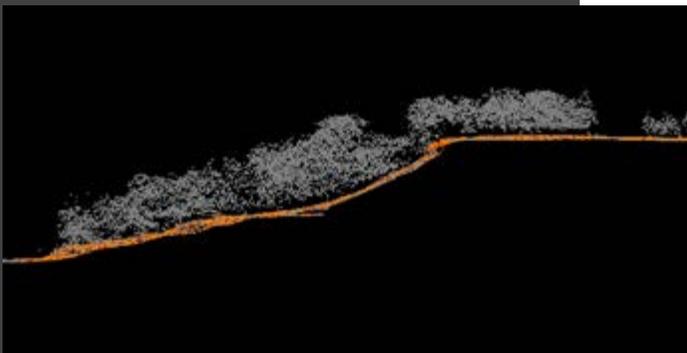
Figure 2a (Below, Left) - Profile of ground surface and vegetation from 2012 USACE LIDAR using LP360

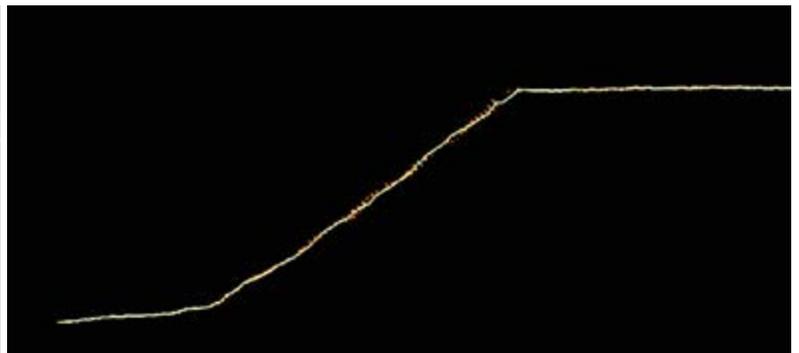
Figure 2b (Below, Right) - Profile of draped ground line with vegetation filtered out using LP360

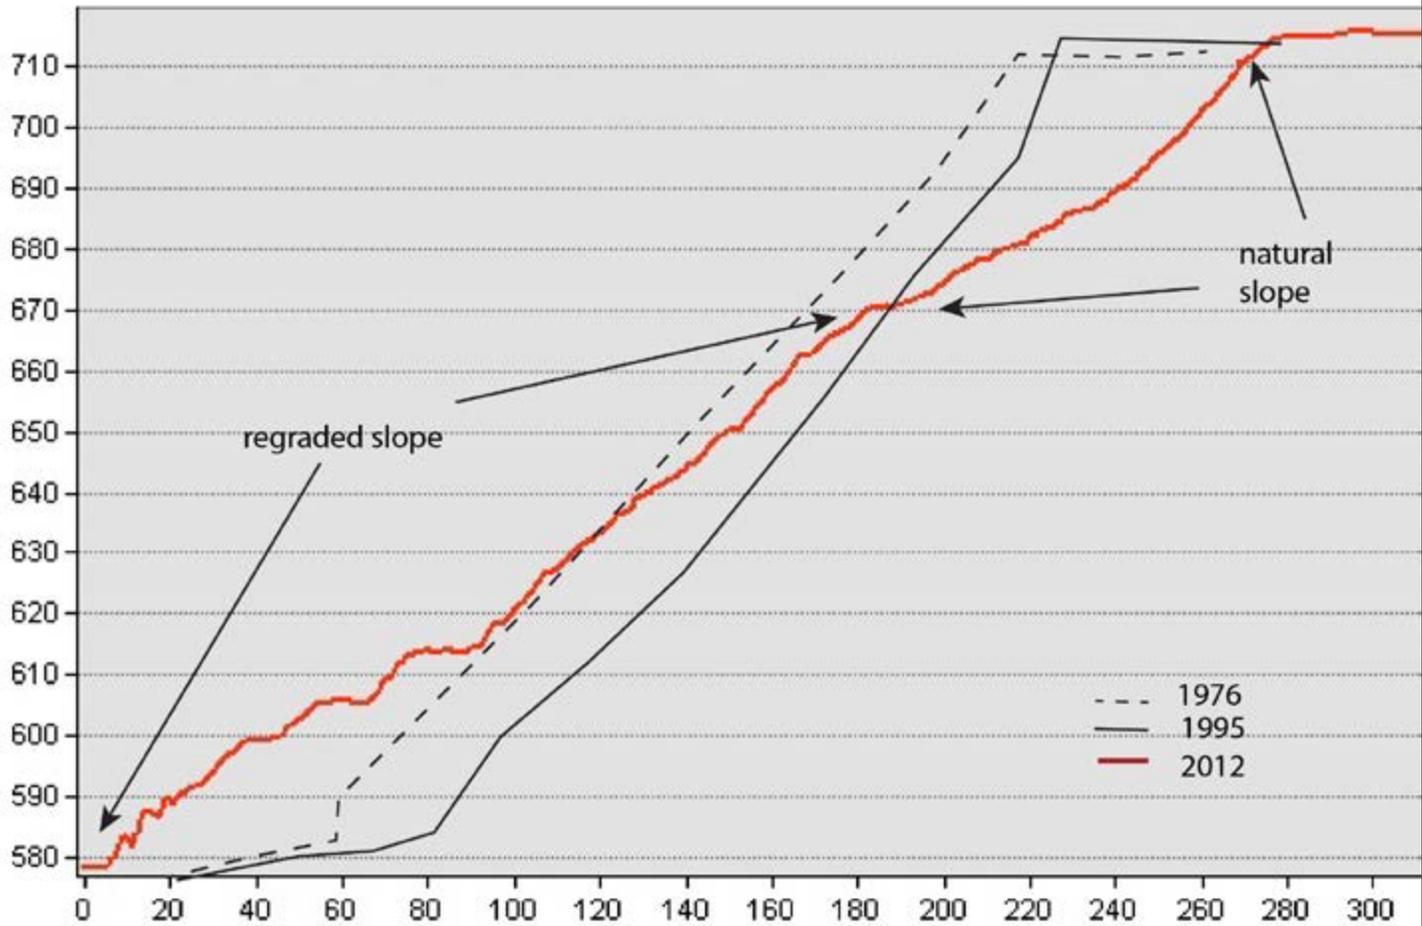
The bluffs have definitely become more stable since 1995. In 1995, of the 105 profiles analyzed to date, the slope with the highest value of the lowest factor of safety was 3.30, but in 2012 that value was 3.82. In 1995, 54 of the 105 profiles had lowest factor of safety's greater than 1.00. In 2012 81 profiles had lowest

factor of safety greater than 1.0. Of the 105 profiles that were analyzed from 1995 and 2012, 71 increased their lowest factor of safety, thus becoming more stable. Of the 105 profiles, 29 became less stable. Five profiles had the same factor of safety at both times of measurement.

Figure 5 – Example of slope comparison over time
